US Army Corps
of Engineers
Los Angeles District

Gila River Basin

New River Dam Embankment Criteria And Performance Report

February 1987

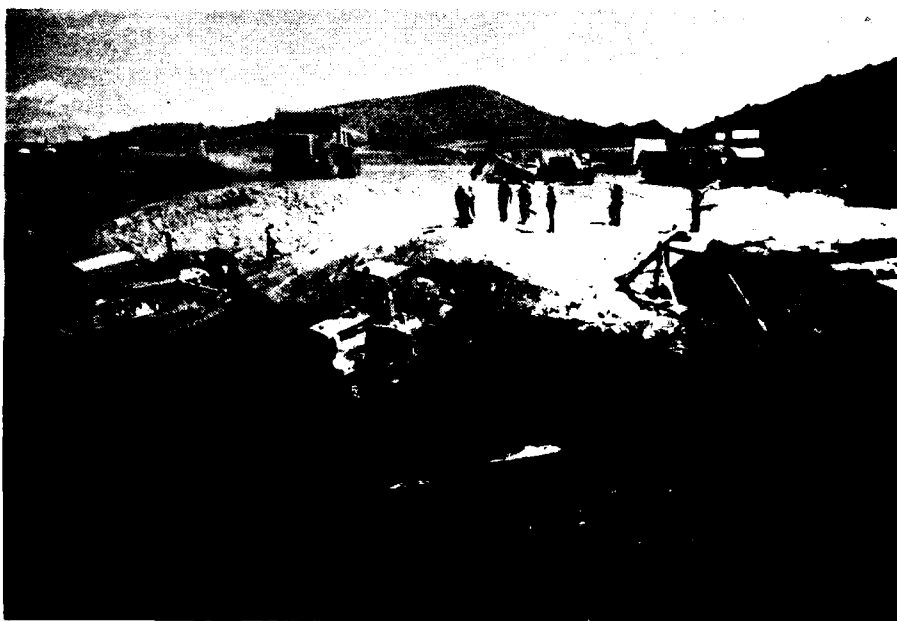
Photo 44. Front end loader compacting core material on
bedrock slope in core trench.
Note dozer using blade to spread material on
foundation surface. April 1984
